INVESTIGATION OF THE USE OF CERAMIC MATERIAL IN AIRCRAFT ENGINE BEAVINGS

Final Report for Period 14 June 1976 - 19 December 1978

Contract: NASC N00019-76-C-0251

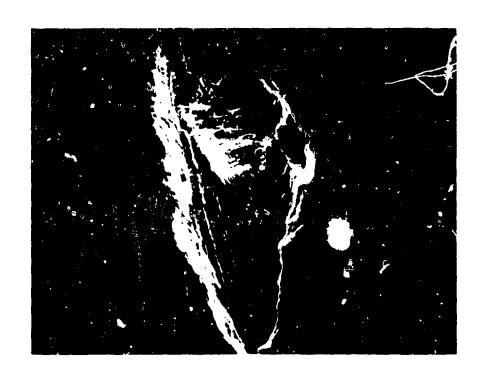
FIGURE 1 - Rod 13 failure spall, 50X SEM

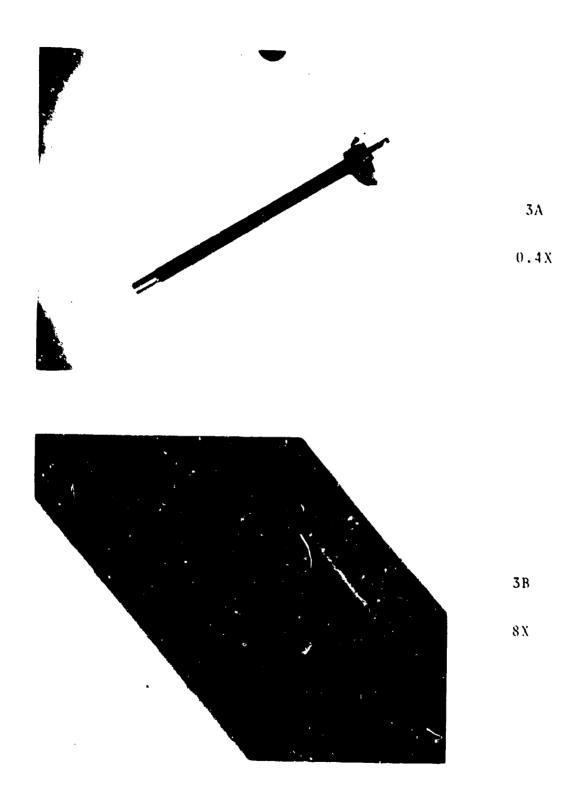
Figure 3B depicts the surface obtained by final grinding with a 600 grit diamond wheel on a cylindrical grinder equipped with a five micron particle filter in the grinding coolant line. This surface exhibits no large random flaws (common without the filter) and very little smearing. The surface finish is 1-2 microinch AA. The mottled structure evident in Figure 3B is due to a high magnesium silicate concentration in the test material; that the structure is clearly evident attests to the minimal surface damage imparted in this final grinding procedure. While the surface finish of these first phase rods is quite acceptable, the geometry was not satisfactory. These rods were 30-60 microinch out of round and the 6 inch rods exhibit a 0.0005 inch barrel shape due to deflection under the high finish grinding pressures.

FIGURES 3A & B - RCF rod, Federal-Mogui

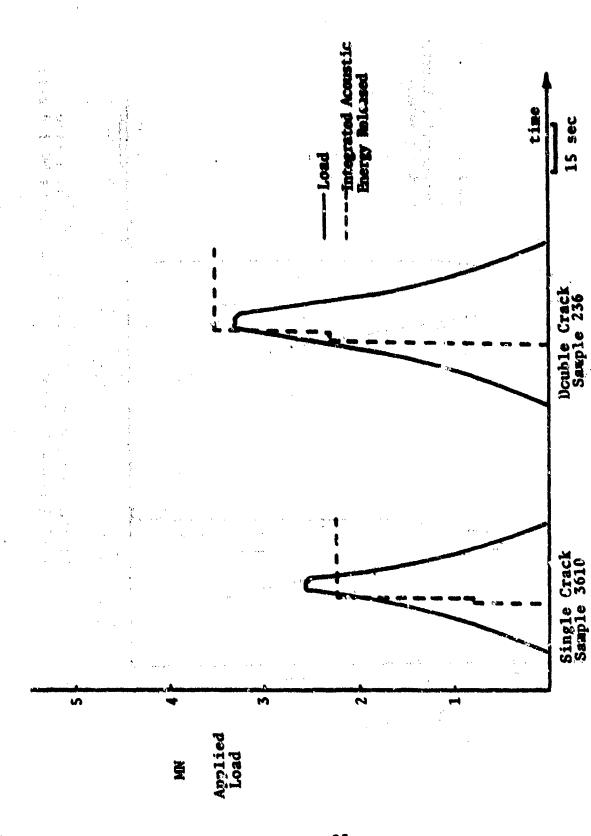
FIGURE 6A - MC-132 Silicon Nitride - Hertzian Contact Behavior - 4.75 mm radius MC indenter

The results of the testing on standardized surfaces are presented in Table 9. The testing shows that the technique is sensitive to changes in material (fracture energy, most likely); but does not accurately reflect measured differences in MOR or small measured changes in fracture energy in a single material. Testing in a 100 percent humidity environment was carried out. NC-132 samples were loaded to 75-85 percent of their mean measured failure load, and held for up to fifteen minutes in the saturated environment. Loading then proceeded to failure; no statistical difference in PC, the critical load, was detected. Thus, the test has not demonstrated that stress corrosion mechanisms operate in NC-132. Testing of abraded surfaces did not greatly reduce the load required for fracture; however, heavy oxidation coatings did impair performance. The heavily oxidized surfaces do not have the integrity of NC-132, most likely due to high contact stresses being

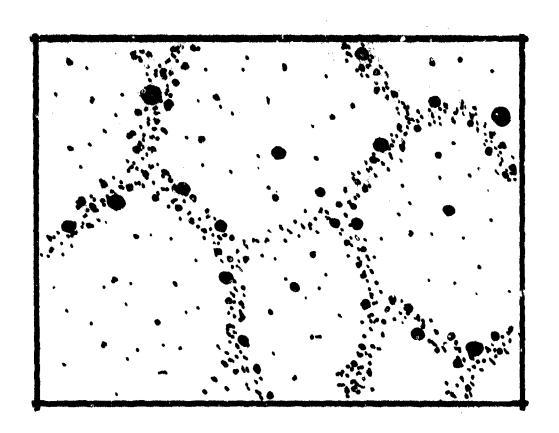
FIGURE 4 - KET Grainy Signature Reconstructed 100X

This is the most interesting structure, particularly in the light that all these rods are felt to have some sub-surface damage. One of these samples was given a thorough optical, SEM, and EDAX characterization in efforts to relate the "island" structure to discernable surface details. A reconstruction of the island structure signature at 100X appears in Figure 4. Indications of such a structure were looked for in various SEM modes. See Figures 5-8. No concentration gradients of the elements detected by dispersive x-ray clearly fall in a similar pattern. Figure 8, SEM in backscatter mode 1000X, clearly shows the pores in the surface; but scanning the surface shows that they are uniformly dispersed. The source of the potassium in the EDAX characterization is un-The potassium concentration in NC-132 silicon nitride is knewn. considerably below the threshold of sensitivity for dispersive x-ray analysis. Conference with both Qual-X and Kodak have not revealed any likely source. Optical microscopy of the same area
